TECHNICAL REPORT ARCCB-TR-99017

ANALYSIS OF MOLTEN SALT AND SPUTTER-DEPOSITED COATINGS ON STEEL CYLINDERS

S. L. LEE M. CIPOLLO D. WINDOVER C. RICKARD

OCTOBER 1999

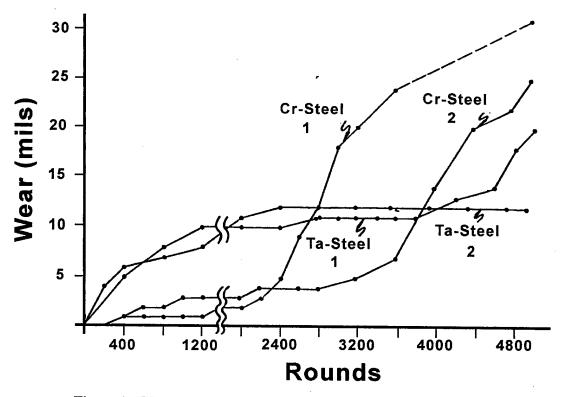
Oxidation of tantalum was observed in molten salt-deposited tantalum, and in triode-sputtered tantalum in our previous work (ref 16). Tantalum oxidizes to form predominantly Ta₂O₅ at 1400°C. Ta₂O₅ has a melting point temperature of 1872°C, and is moderately passivating. Our current work discovered that oxide formation increases with the number of rounds fired. As shown in Figure 1, the increasing oxides do not cause further degradation of the coatings or the substrate.

Figure 1. Wear versus rounds in typical electrochemical-deposited tantalum and chromium liners from molten salt.

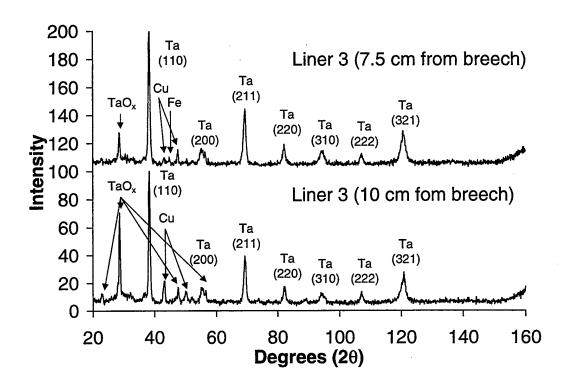
Liner 3—20-cm long and 20-mm diameter—was coated with 127 μ m of tantalum, and exposed to 5034 cycles consisting of temperatures above 1000°C and pressures above 700 MPa. After firing, it was sectioned axially into eight pieces. Figure 3a compares the x-ray diffraction patterns of two specimens cut 7.5-cm and 10-cm from the breech end of the liner. X-ray data disclosed surface α -phase tantalum, tantalum oxide (predominantly Ta_2O_5), copper debris (which came from the fired projectiles), and weak steel peaks. Figure 3b shows the ratio of x-ray diffraction tantalum oxide intensity-to-tantalum intensity along the axial direction for Liner 3. Diamonds represent the relative intensity of the Ta_2O_5 peak at $2\theta = 28^\circ$ to the tantalum peak at $2\theta = 38^\circ$. Dots give the intensity of the sum of all tantalum oxide peaks relative to the total intensity of the tantalum peaks. The graph shows that oxidization was higher near the breech end, and fell off at approximately 9-cm from the breech, reflecting the variation of operation temperature and pressure along the liner axis.

Figure 3a. X-ray diffraction patterns of two specimens cut 7.5-cm and 10-cm from the breech end of Liner 3.

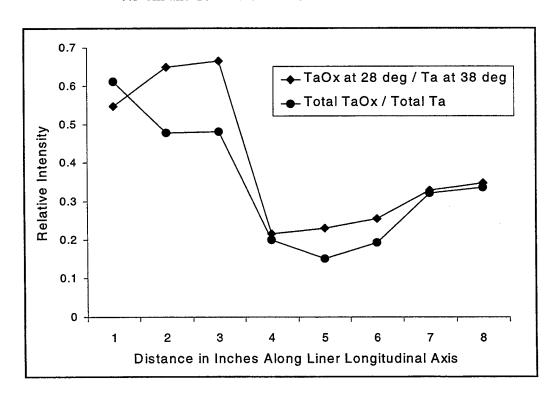
Liner 1—20-cm long and 20-mm diameter—was coated with 76 μ m tantalum, and exposed to 1097 thermal cycles. The x-ray diffraction patterns of Liner 1 were very similar to those of Liner 3. The intensity ratio of the Ta₂O₅ peak in Liner 3-to-Liner 1 was 1.7. This demonstrated that oxidation of tantalum depends on the operation history, and increases with rounds fired.

Figure 3b. Ratio of tantalum oxide versus tantalum x-ray intensities as a function of axial distance for Liner 3.

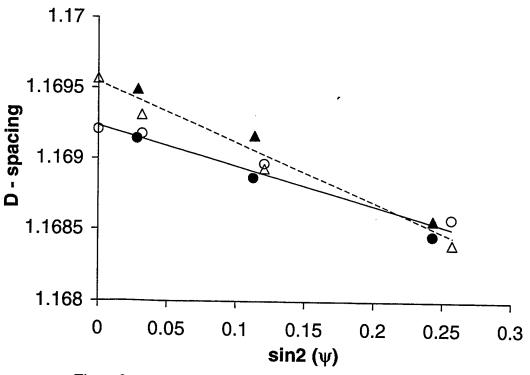
X-ray stress analysis of Liner 3 after 5034 rounds revealed approximately 280 MPa compressive residual stress toward the breech end and 560 MPa compressive residual stress toward the muzzle end. Figure 3c shows the $\sin^2(\psi)$ curves, which were relatively linear because of the random crystalline orientation in molten salt-deposited tantalum. Stress measurements were performed in the groove area of the liners in the axial direction. Deposition residual stresses in the axial and hoop directions were not expected to vary significantly, but the radius-of-curvature and the liner geometry made it difficult to perform hoop stress determination and thereby verify the data.

Figure 3c. Residual stress at the breech end and muzzle end of Liner 3. (Triangles represent data at the breech end and dots represent data at the muzzle end.)

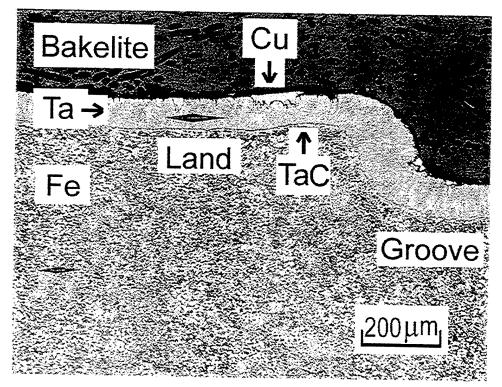
Figure 4a shows a photomicrograph of Liner 1 after sectioning, mounting, polishing, and etching. The figure shows a uniform, all α -phase tantalum coating with columnar growth, and surface copper debris. A 'swaging effect' resulting in an enlarged land section and a diminished groove section can also be seen. Note the ductility of tantalum allowed it to flow accordingly. Figure 4b is a photomicrograph of Liner 1, showing that the fatigue cracks are likely to occur near the land-to-groove transition region with very high plastic strain. Figure 4c shows the photomicrograph of Liner 3 giving hardness measurements performed. The average thicknesses of the eight sections in Liner 3 were 112 μm in the land, 90 μm in the groove, and 148 μm in the thickest swaged areas.

Figure 4a. Photomicrograph of tantalum Liner 1 showing swaging effect of the coatings and surface copper debris.

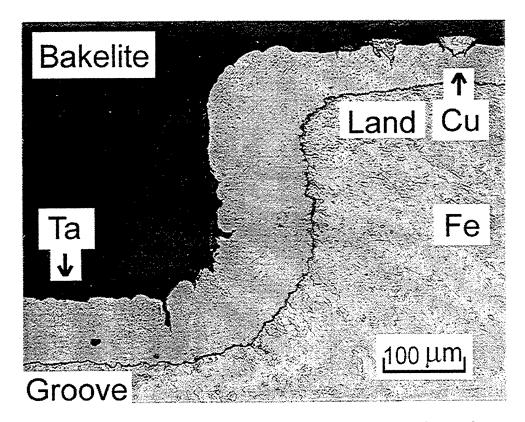
Figure 4b. Photomicrograph of Liner 1 showing crack pattern in tantalum.

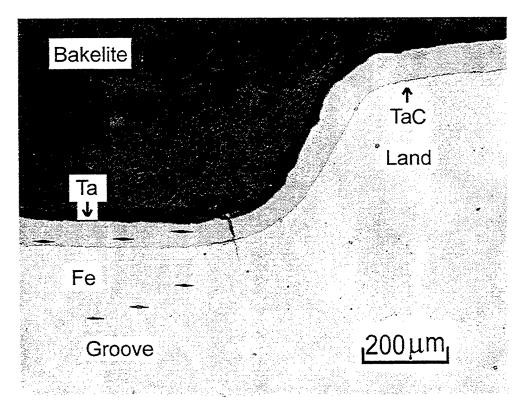
Figure 4c. Photomicrograph of Liner 3.

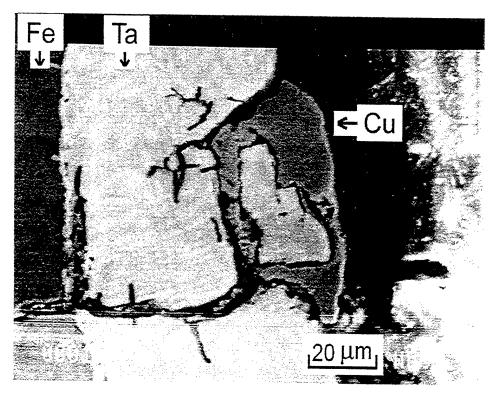
Figure 4d is a scanning electron micrograph depicting a piece of tantalum encased in melted copper. A crack initiated at the sharp edges of the casing, propagated toward the interface, and generated a pronounced crack in the steel substrate and a crack along the interface. Figure 4e is scanning electron micrograph depicting a crack that was initiated at the coating surface. The crack propagated through the thickness of the coating and generated a wider crack in the steel and a smaller horizontal crack along the interface. The wider crack width in the steel indicates that steel is much less resistant to high temperature and pressure chemical attack. Energy dispersive x-ray analysis showed copper, tantalum, and steel in the cracks. Fine copper particles were also observed in the horizontal crack along the interface.

Figures 4d and 4e show a 2- μ m thick interface layer between tantalum coatings and steel substrate. This interface layer was previously observed in a molten salt coating with a hardness of ~640 Vickers₅₀ (~790 KHN₅₀), but was not identified (ref 5). Our energy dispersive x-ray analysis of this layer using a 5 kV electron beam at 30,000× magnification disclosed tantalum and carbon in the layer. Carbon is believed to evolve from the steel substrate surface during tantalum deposition, and its concentration should increase with temperature. Hardness measurements included ~240 Vickers₅₀ (~294 KHN₅₀) in molten salt α -phase tantalum, 810 to 1000 Vickers₅₀ (1000 to 1220 KHN₅₀) in molten salt β -phase tantalum, and ~390 Vickers₅₀ (~480 KHN₅₀) in the steel substrate.

Figure 4d. Scanning electron micrograph depicting a piece of tantalum encased in melted copper.

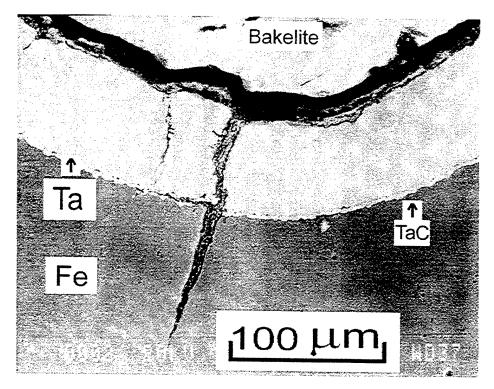
Figure 4e. Scanning electron micrograph depicting crack growth in steel and along the tantalum/steel interface.

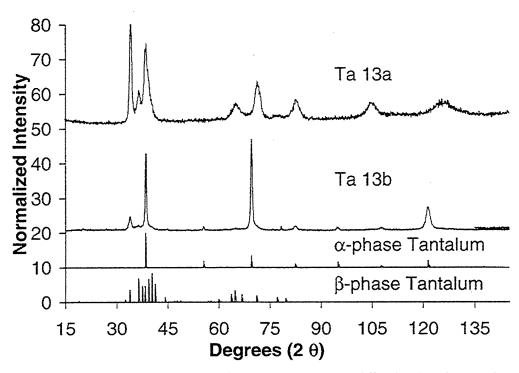
Figure 5a reveals the surface x-ray diffraction scans of two specimens cut from the same cylinder deposited at 12 and 13 Pa (90 to 100 mTorr) argon pressure. Ta13a was deposited at ~150°C, and Ta13b at ~400°C substrate temperature. Ta13a, deposited at the lower temperature, showed predominantly \(\beta \)-phase tantalum, characterized by the strong preferred [002] orientation. Ta13b, deposited at the higher temperature, showed predominantly α-phase tantalum, with a small concentration of β-phase tantalum, again characterized by the [002] orientation. Figure 5b reveals the microstructure for Ta13a. The microstructure exhibited coarse and fine growth columns with extensive voids. The topography, seen in Figure 5c, included dome-topped structures with voids. The specimen was a typical zone 1 porous structure as described by Thornton (refs 17-19). Figure 5d reveals the microstructure of Ta13b. This microstructure showed nucleation in the β -phase, and growth of the fan-shaped α phase. The topography of the polished and etched Ta13b surface, found in Figure 5e, included smooth facets with dimension on the order of 1 µm. Hardness measured ~344 Vickers₅₀ (~426 KHN₅₀), in Ta13b, using a diamond pyramid on a Leco M400 microhardness tester. This value is close to, but higher than the ~281 Vickers₅₀ (~350 KHN₅₀) hardness reported for bulk α -phase tantalum. The higher value was due to the small β -phase component in the Ta13b specimen. Hardness in β -phase, Ta13a was ~820 Vickers₅₀ (~1009 KHN₅₀).

Figure 5a. X-ray diffraction of cylindrical magnetron sputtered Ta13a showing predominant β -phase tantalum with traces of α -phase tantalum, and Ta13b showing α -phase tantalum.

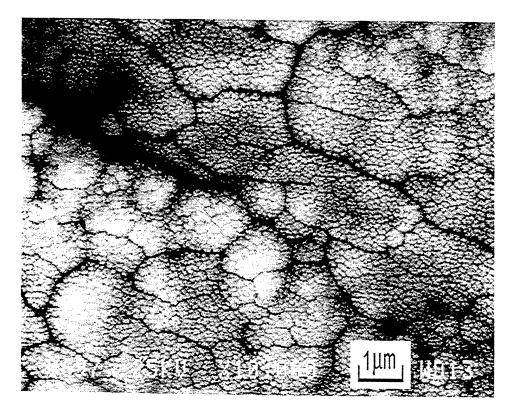
Figure 5c. Topography of Ta13a, including domed tops with large voids.

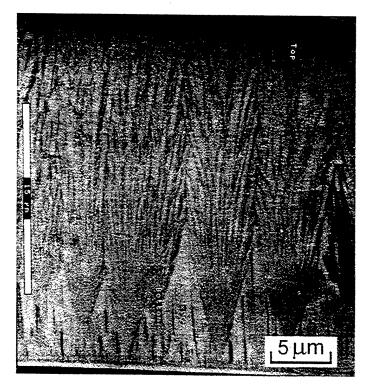
Figure 5d. Cylindrical magnetron sputtered Ta13b microstructure revealing $\beta\text{-phase}$ nucleation at the interface, and growth of $\alpha\text{-phase}$ tantalum.

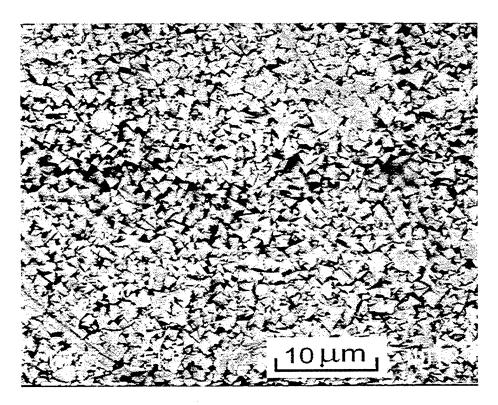
Figure 5e. Topography of Ta13b, including faceted surface.

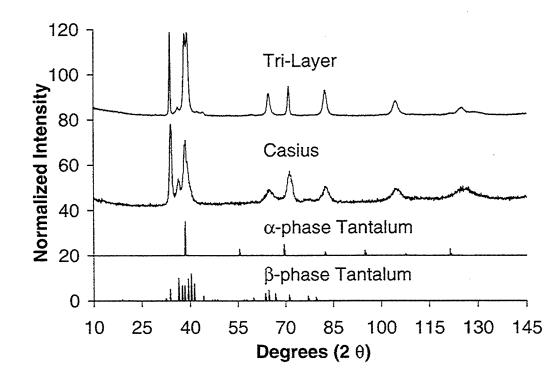
Figure 6a presents the x-ray diffraction of two other cylindrical magnetron sputter-deposited specimens. The top pattern is from a 50- μ m tri-layer coating, which was sputtered at 20, 13, and 9 Pa (150, 100, and 70 mTorr). The pattern shows surface β -phase tantalum and a doublet peak at $2\theta = 40^{\circ}$. Nitrogen purging was used at the end of the deposition of the tri-layer coating to prevent oxidation, which may form surface tantalum nitrides. The second pattern is for the Casius coating deposited at 33 Pa (250 mTorr). It shows surface β -phase tantalum with broadened diffraction peaks compared to the tri-layer coating. Microstrain and particle size can introduce diffraction peak broadening. Kinetic processes in sputtering control the physical characteristics of the coatings. Figure 6b demonstrates that coating morphology changed with changing argon pressure in the tri-layer coating: bottom layer at 20 Pa (150 mTorr), middle layer at 13 Pa (100 mTorr), top layer at 9 Pa (70 mTorr). Figure 6c is a laser photomicrograph of the specimen taken at 33 Pa (250 mTorr) showing coating porosity. This coating has a density of 10.5 gm/cm³ calculated from weight loss of the target. At high argon pressure, porosity is expected due to the atomic shielding effect of the argon atoms.

Figure 6a. X-ray diffraction of two cylindrical magnetron sputtered specimens, from a tri-layer coating and a Casius coating.

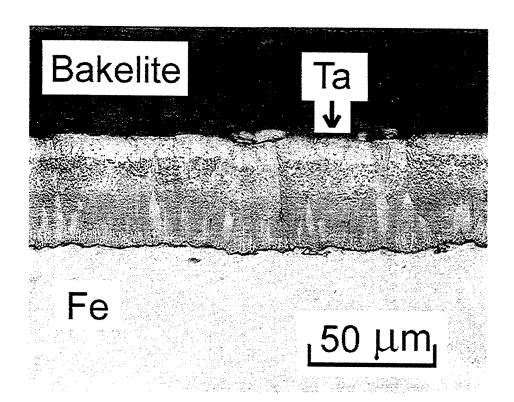
Figure 6b. Photomicrograph demonstrating coating morphology changes with changing argon pressure in the tri-layer coating.

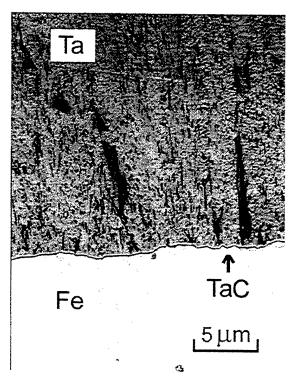
Figure 6c. Laser photomicrograph of specimen taken at 33 Pa (250 mTorr) argon pressure showing coating porosity (1200×).
